PIKE COUNTY, PENNSYLVANIA
PHASE II INSPECTION REPORT
NATIONAL DAM INSPECTION PROGRAM

PHASE I REPORT
NATIONAL DAM INSPECTION PROGRAM

Name of Dam: LOWER HEMLOCK DAM
State & State No.: PENNSYLVANIA, 52-117
County: PIKE
Stream: TRIBUTARY TO ROCK HILL CREEK
Date of Inspection: April 2, 1980

LOWER HEMLOCK DAM

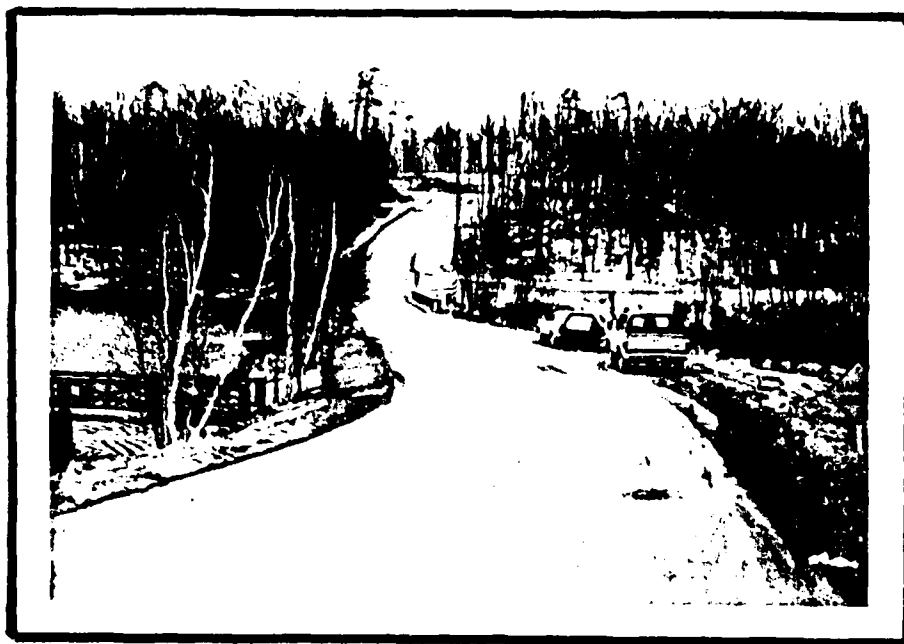
OVERVIEW FROM RIGHT ABUTMENT - NO. 2

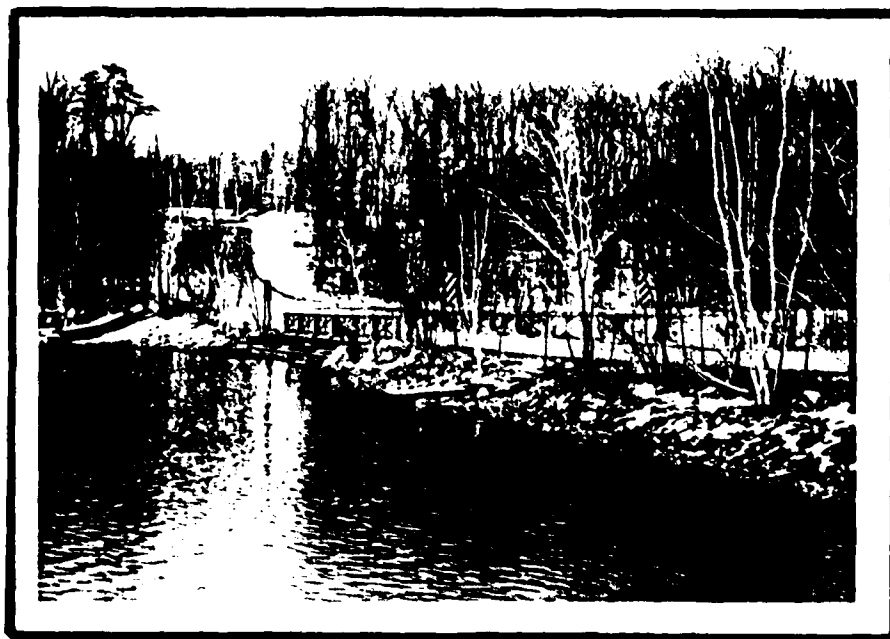
The upstream slope has a good riprap protection and appears to be flatter than the design slope above the normal pool elevation. Trees have been planted on this slope to enhance the surroundings. Tree roots are not desirable on an earth embankment and it is recommended that the trees be removed. The top of the dam is one of the main roads in this residential development. A bituminous road surface covers most of the dam crest. Longitudinal cracking in this surface appears to be normal pavement distress. The dam is located in a low area between two hill-sides. The profile (Plate A-II, Appendix A) indicates that the crest of the dam is in a sag, with only a short low area.

UPSTREAM SLOPE - NO. 3
NOTE TREES

The operational procedures for Lower Hemlock Dam are minimal at the present time. It is recommended that the trees on the upstream slope be removed and that the valve be greased and operated at least once each year. A formal surveillance and downstream warning system should be developed for implementation during periods of high or prolonged rainfall.

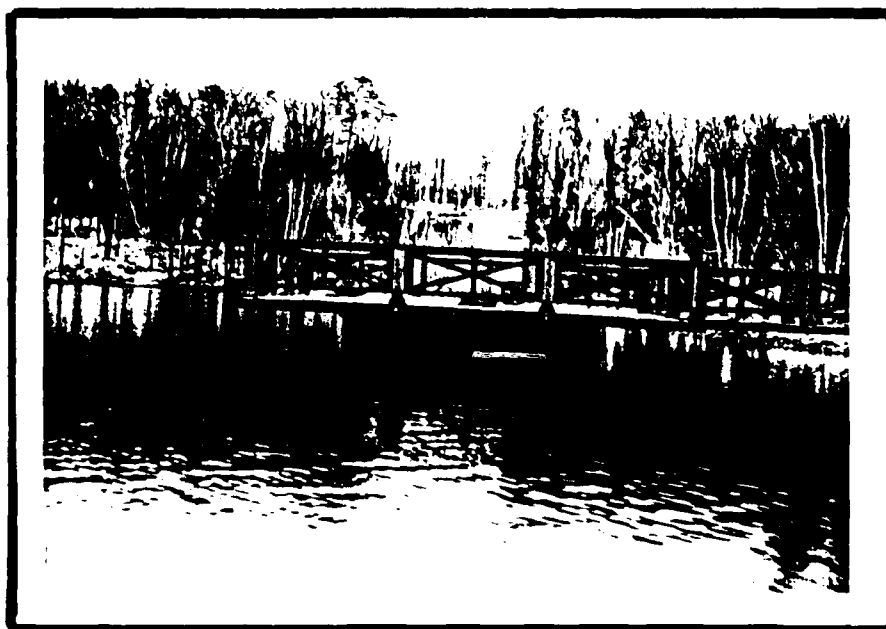
The valve chamber is accessible from the crest of the dam. The top of the valve chamber is 2.8 feet above normal pool elevation. The platform is large and overhangs the actual chamber on all sides. A long valve stem, which is stored inside the chamber, can be lowered through a hole in the slab to the top of the valve. The valve was operated during the inspection and is in good condition.

VALVE CHAMBER - NO. 5

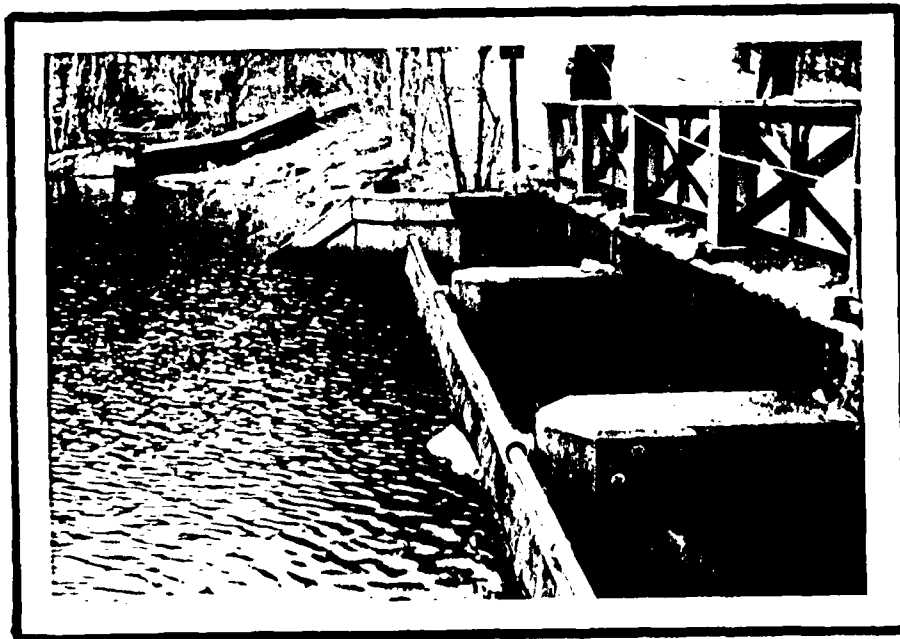
The spillway weir and spillway abutment walls are in good condition. Only minor deterioration was noticed. The fish guard-screen on top of the weir, about 1.5 feet high, is not desirable. Clogging could occur and reduce the efficiency of the spillway. The bridge and supporting piers carrying the road over the spillway were in good condition.

A fish guard-screen is installed at the upstream face of the ogee weir. This screen has the potential for becoming blocked by debris and thus considerably reducing the spillway capacity. No other conditions were observed that would indicate that the appurtenant structures of the dam could not operate satisfactorily during a flood event until the dam is overtopped.

SPILLWAY WEIR AND FISH GUARD - NO. 7

The overall visual evaluation of Lower Hemlock Dam indicates that the dam is in fair condition. The seepage condition at the downstream toe is not considered serious at the present time but should be observed on a regular basis. The trees on the upstream slope should be removed and it is recommended that the fish guard-screen on the spillway also be removed.

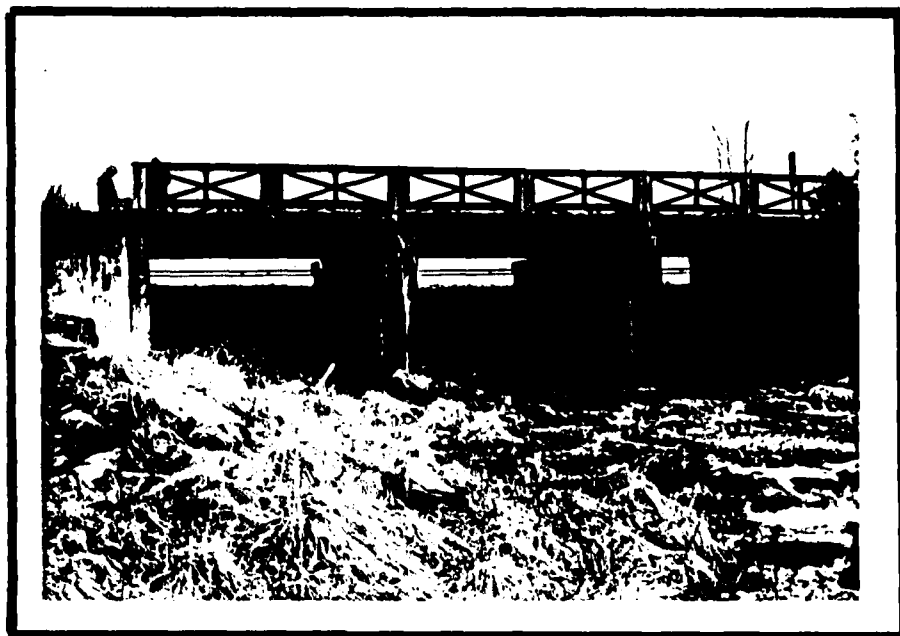
SPILLWAY AND BRIDGE LOOKING UPSTREAM - NO. 8
